October 2021 CAP Meeting Lake Success

Tom Stilley, Corteva Remediation Group Leader

October 12, 2021

Success Lake Remediation

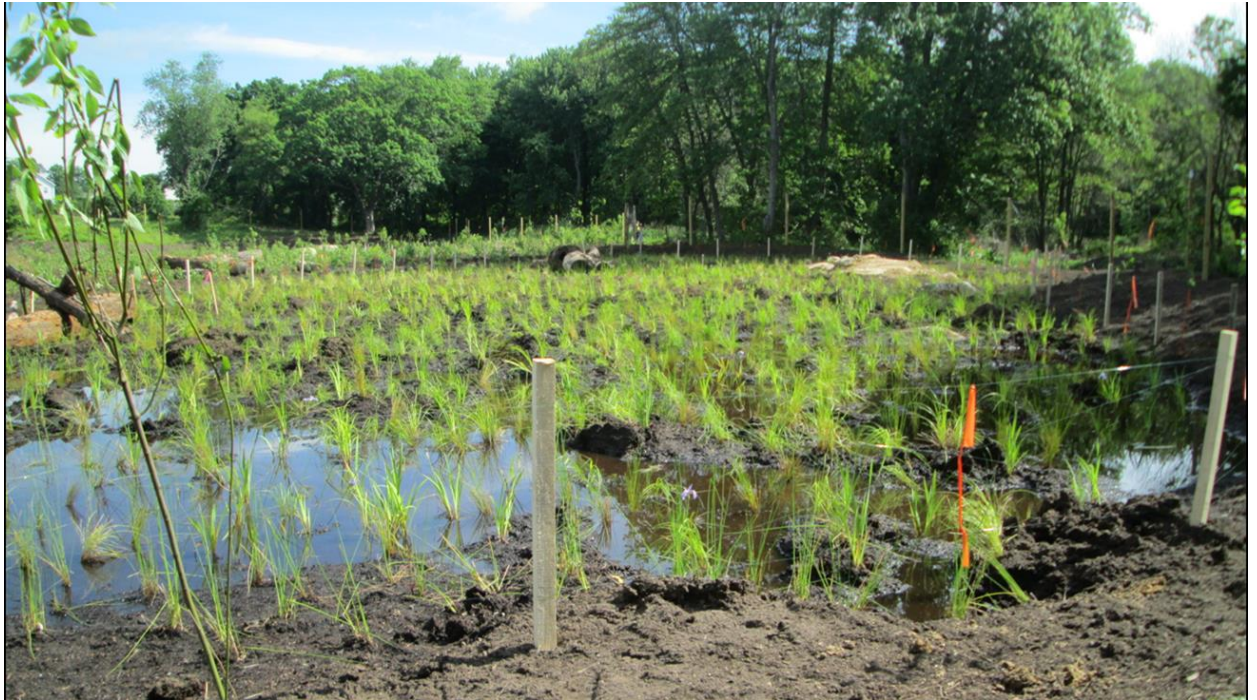
AEC 1-1 Wetland Creation

- Completed AEC 1-1 Monitoring – Required monitoring for 5 years after creation. The wetland met or exceeded all required quality benchmarks for wetlands health and diversity
- 1.78 Acres of wetland created in 2015 after remediation of former open burn area (AEC 1-1)
- Rigorous post-creation maintenance program of vegetation control, deer fence maintenance, invasive species control, and irrigation (when needed)

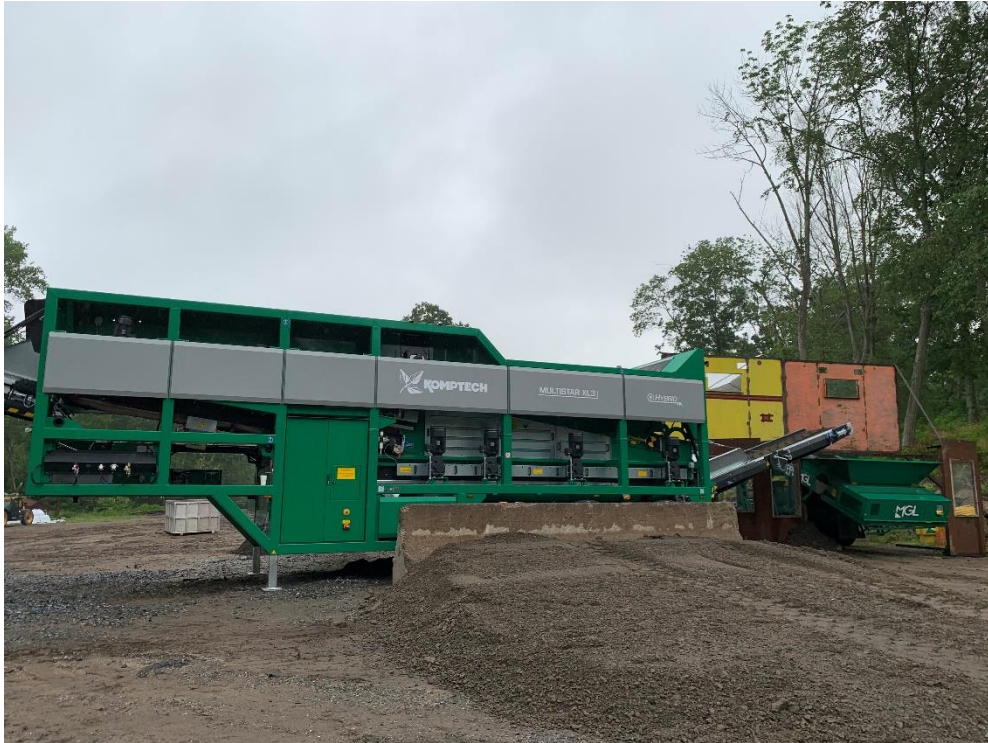
Screening plant for lake tailings

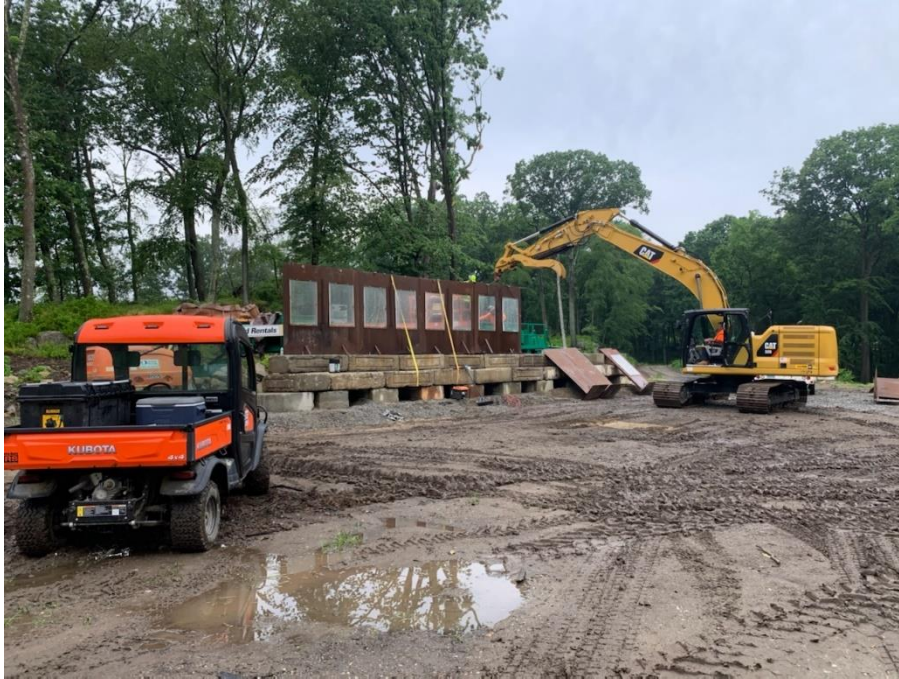
Installing armor to protect technicians

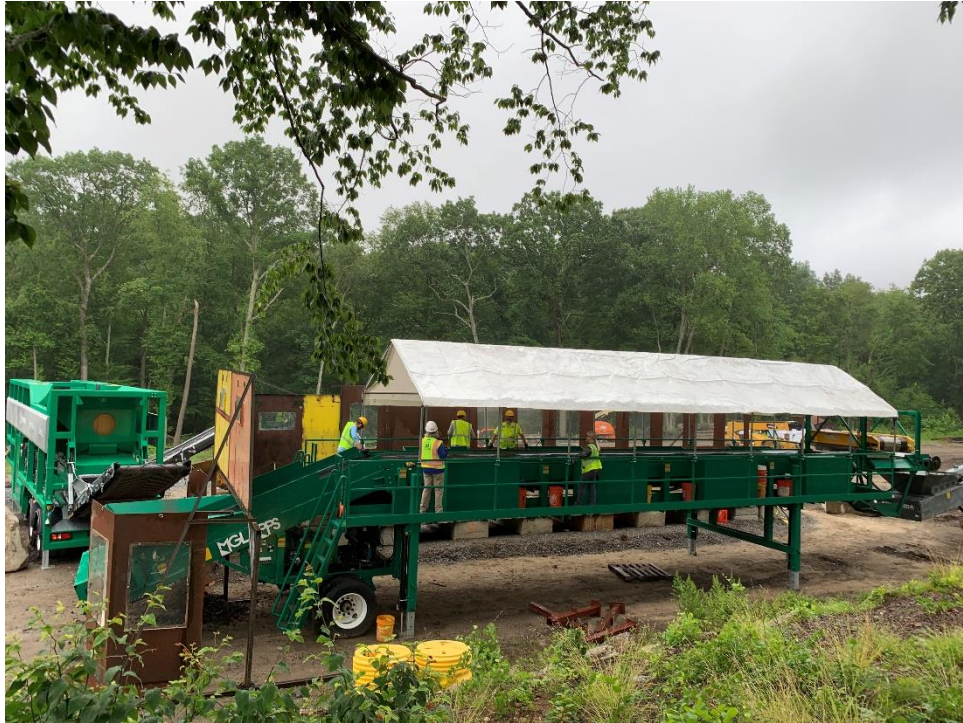
Picking Station manned by UXO technicians

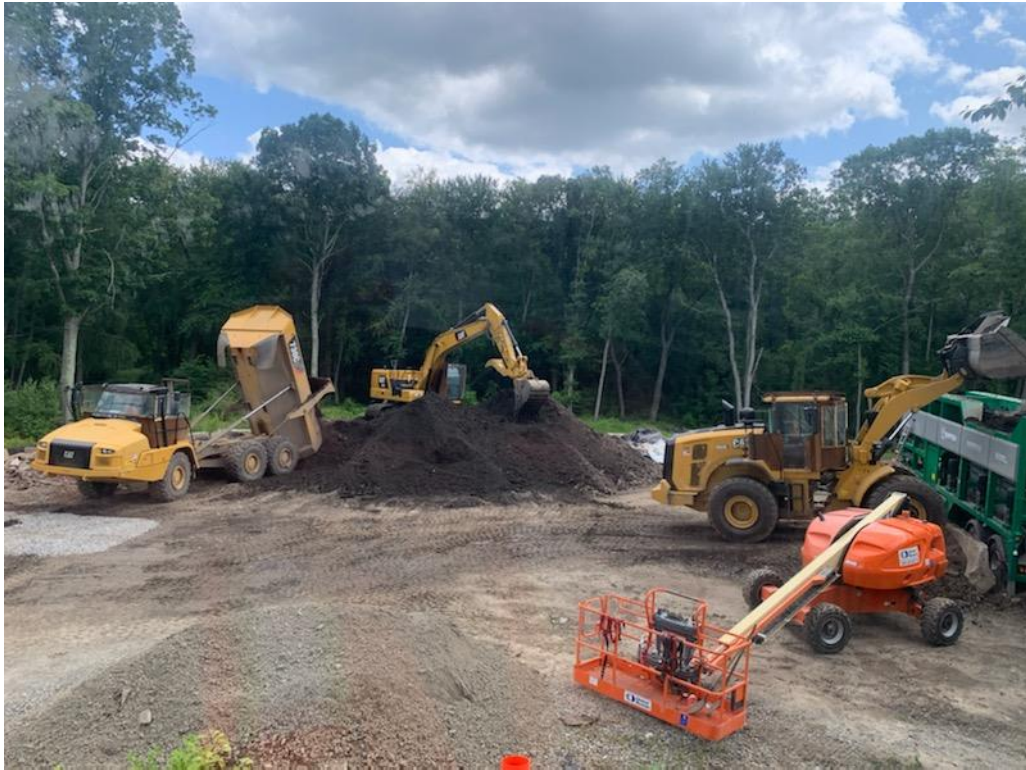
Loading material into screening plant

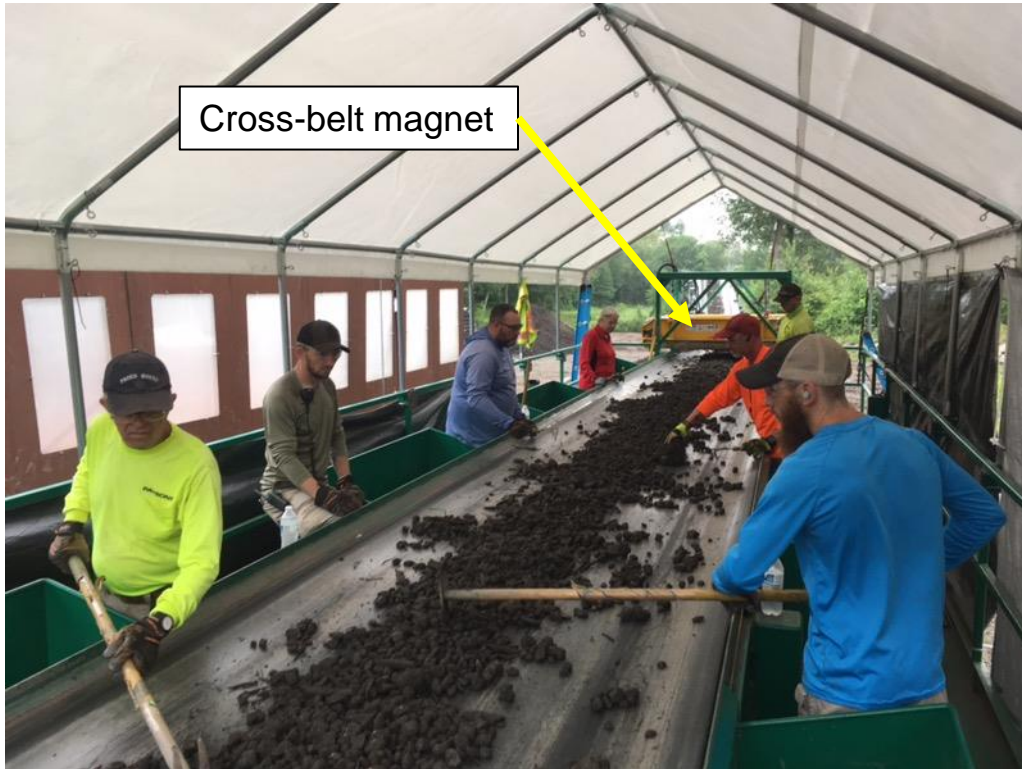
Technicians removing munitions

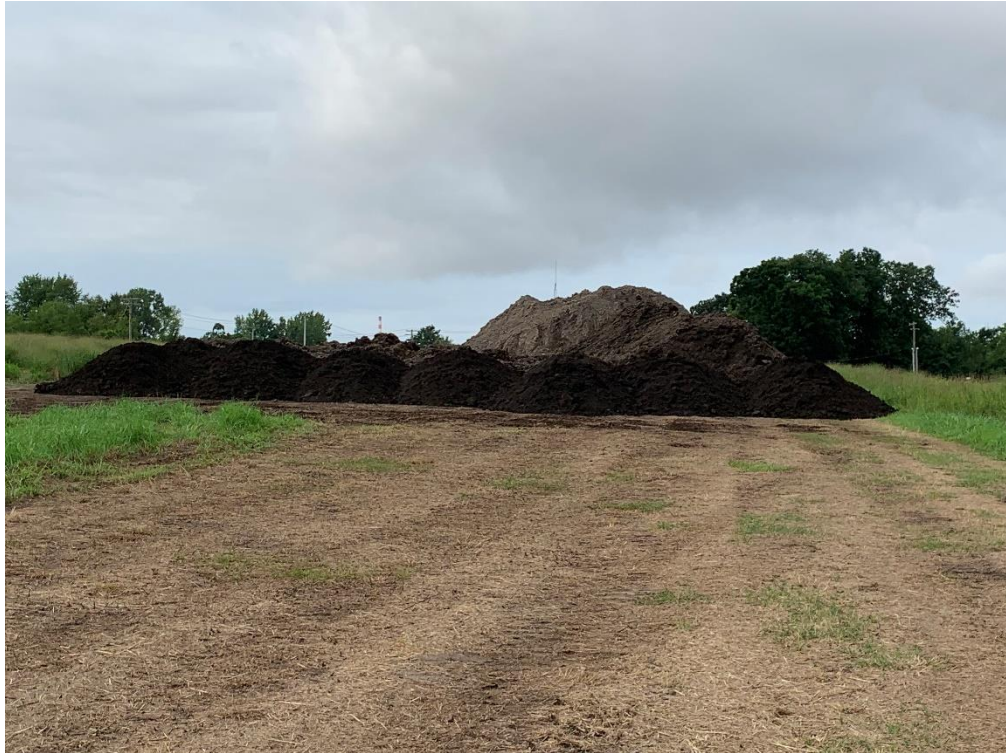
Lake material transported to cap area

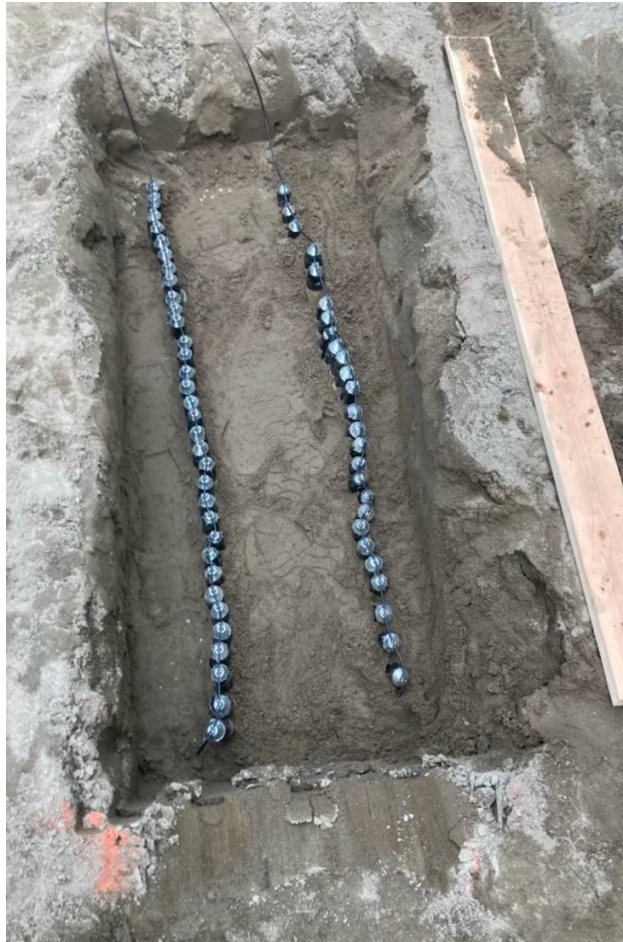
**Munitions
placed in
sand bed
and
connected
to
continuous
blasting
chord**

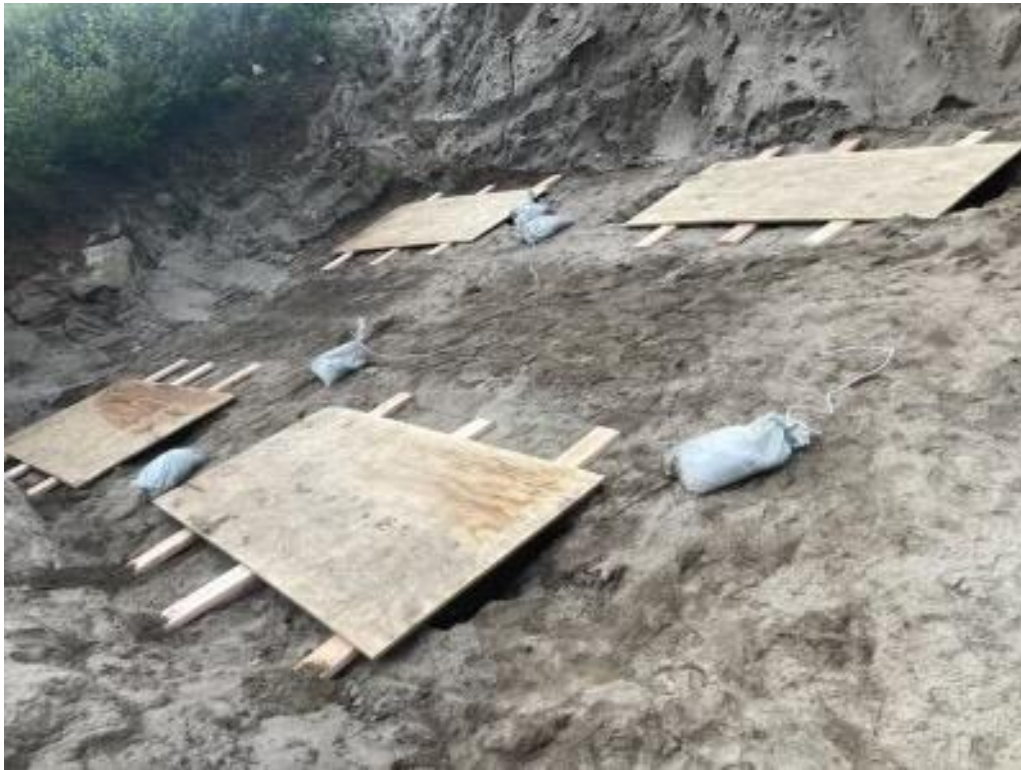
Blast beds covered by plywood prior to being covered with sand

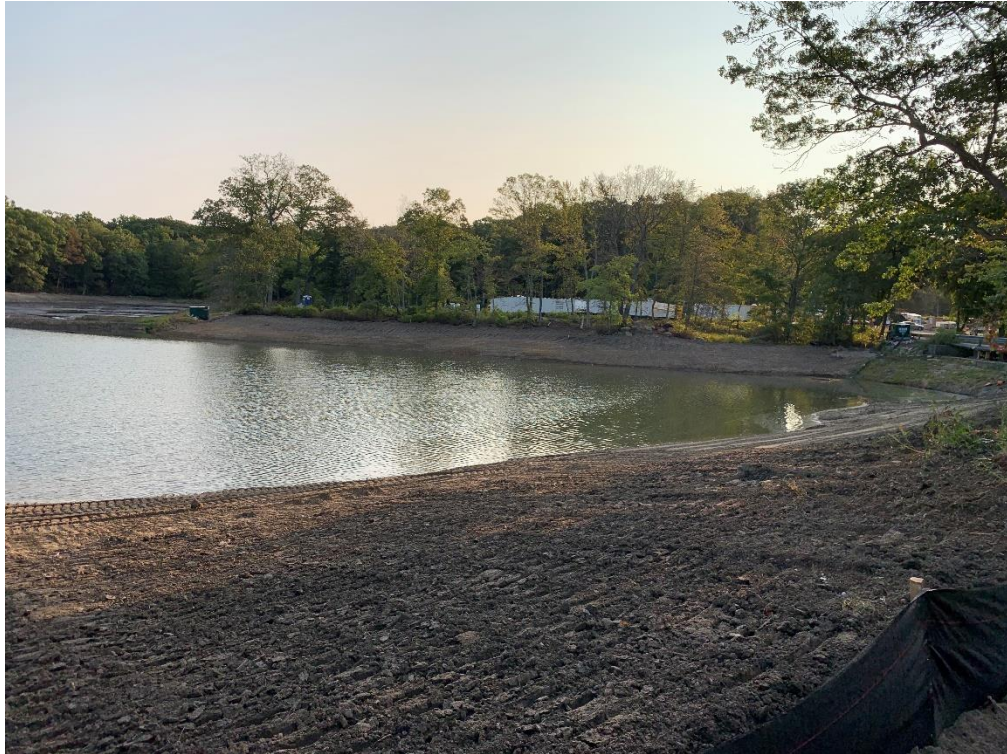
COMPLETED LAKE HABITAT BENCH

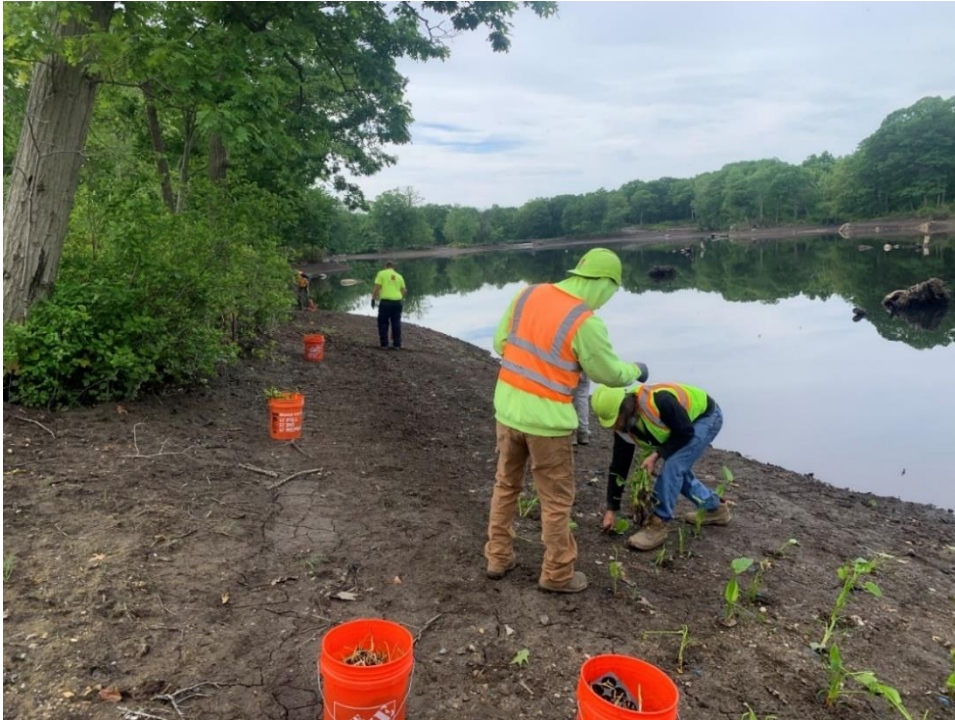
Installing plugs into gentle slope

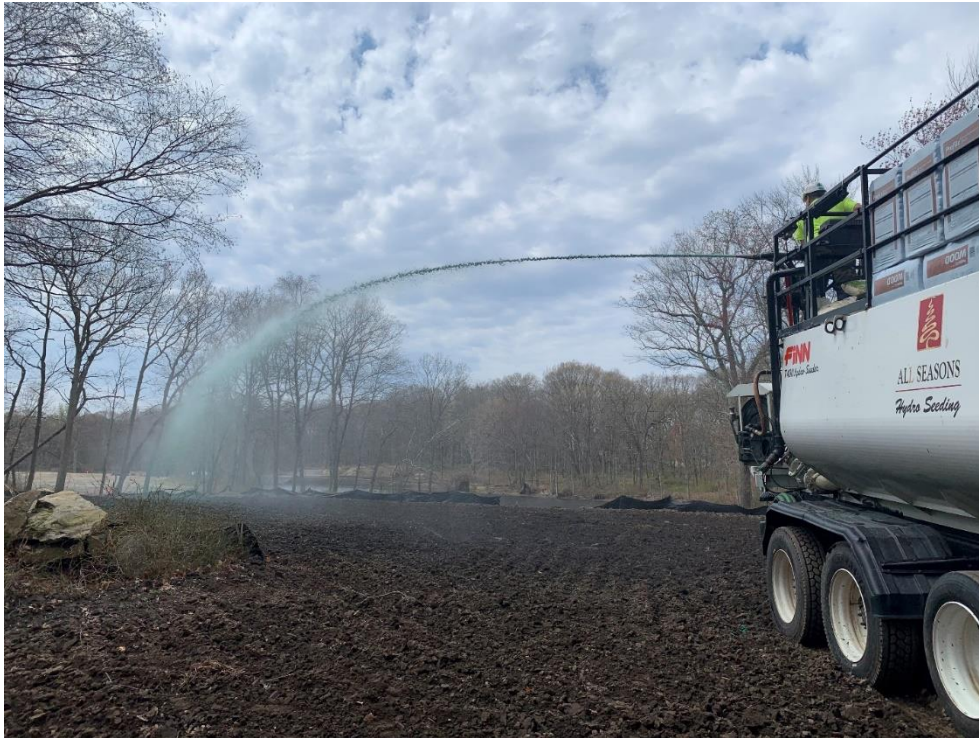
Hydroseeding operation for upland areas

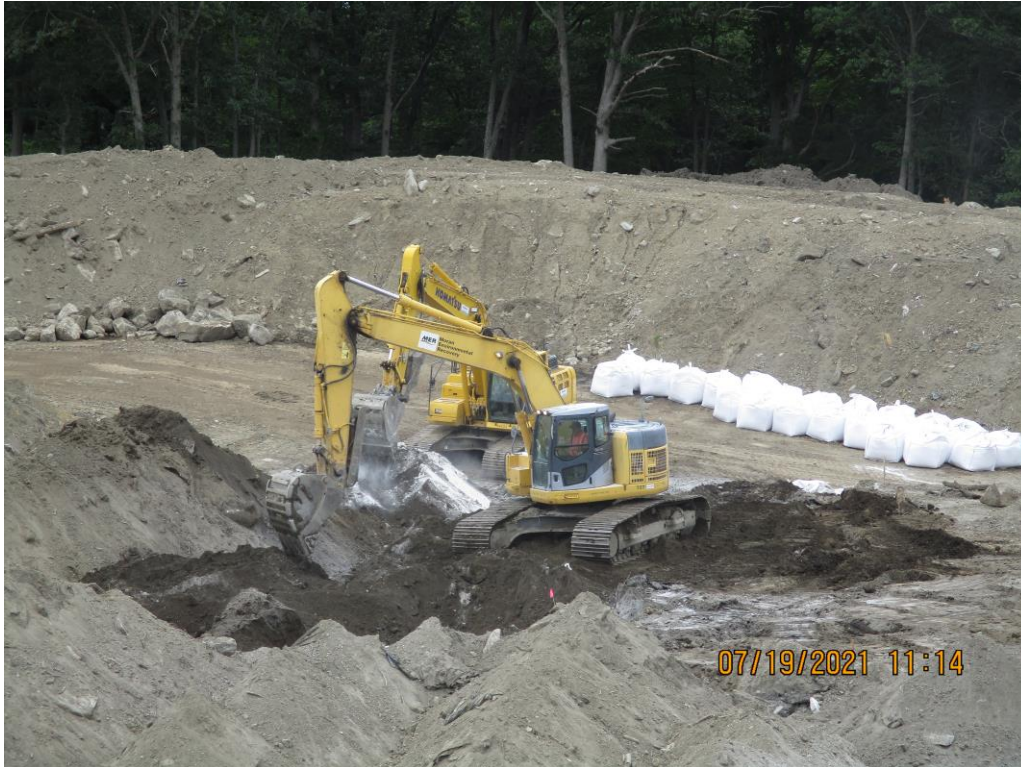
Stabilizing soil so that it meets capping requirements

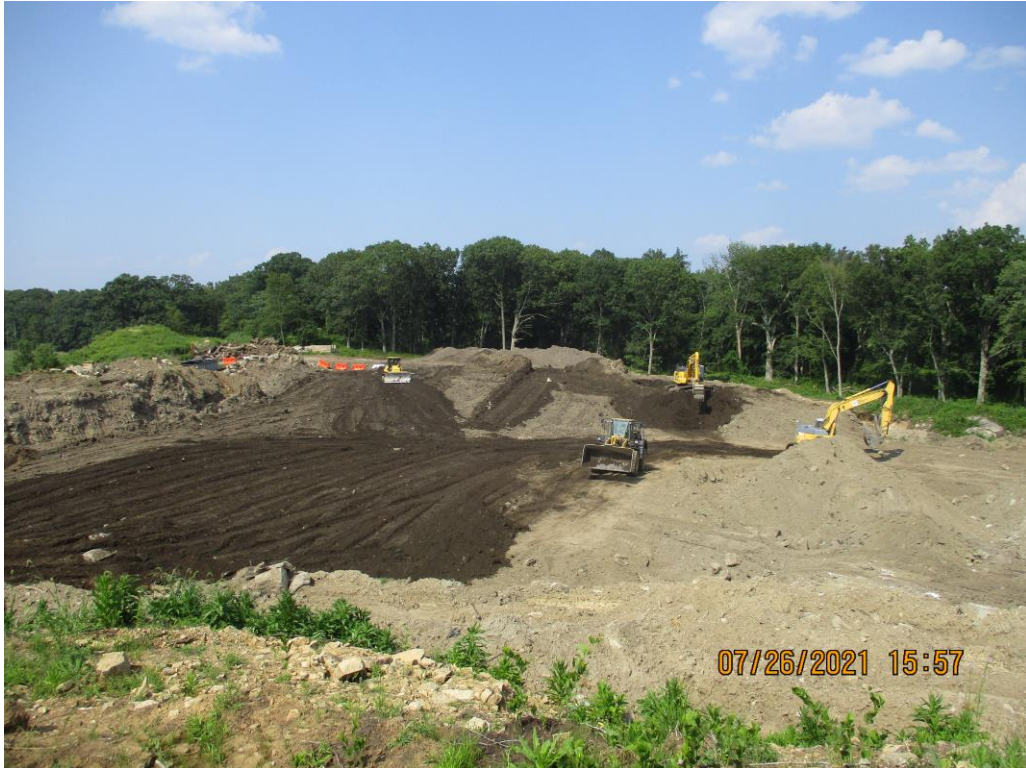
Placing soil in shallow lifts and compacting in place
