December 2022 CAP Meeting - Lake Success

Tom Stilley, Corteva Remediation Group Leader

December 8, 2022

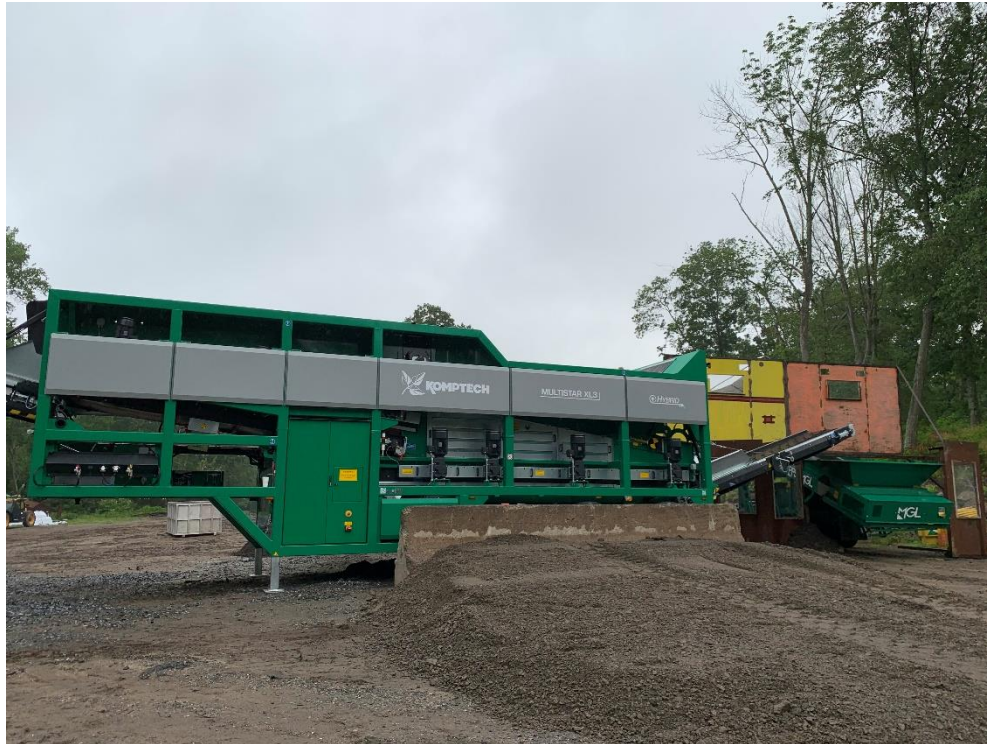
Screening plant for lake tailings

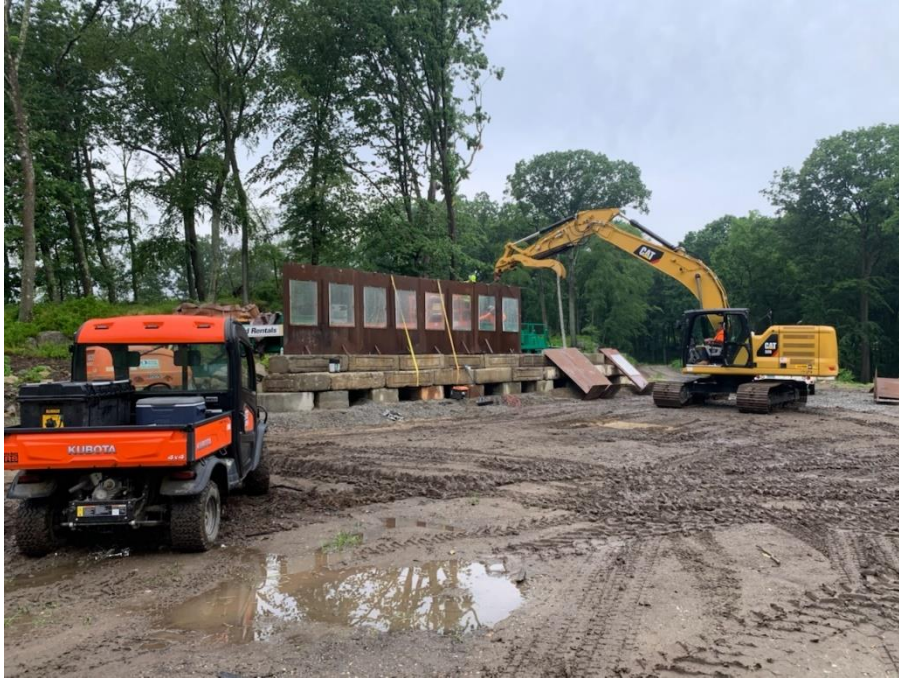
Installing armor to protect technicians

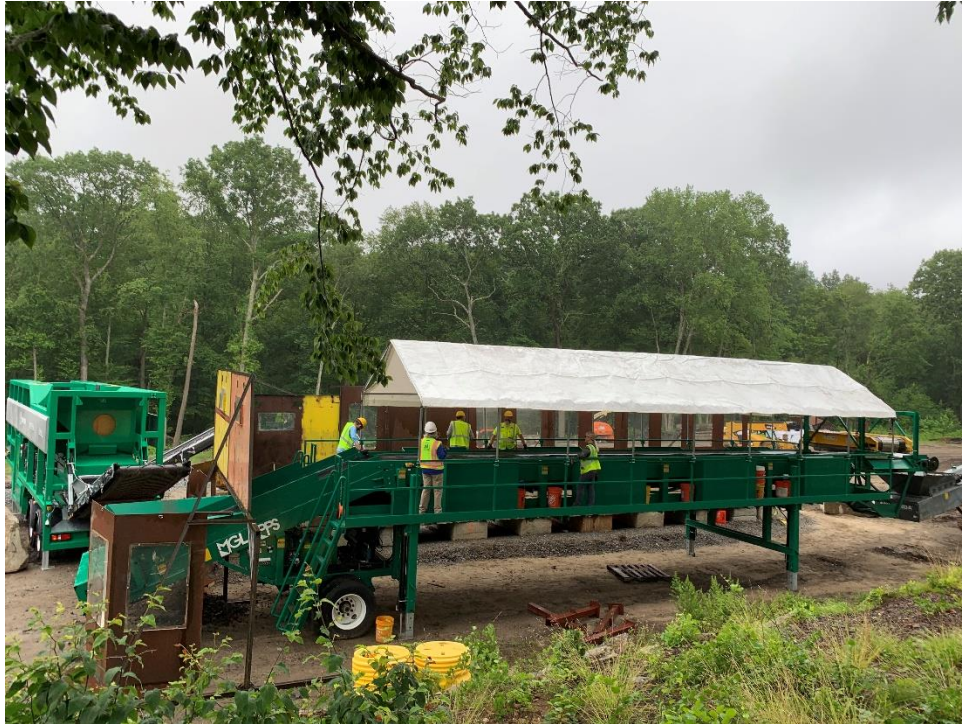
Picking Station manned by UXO technicians

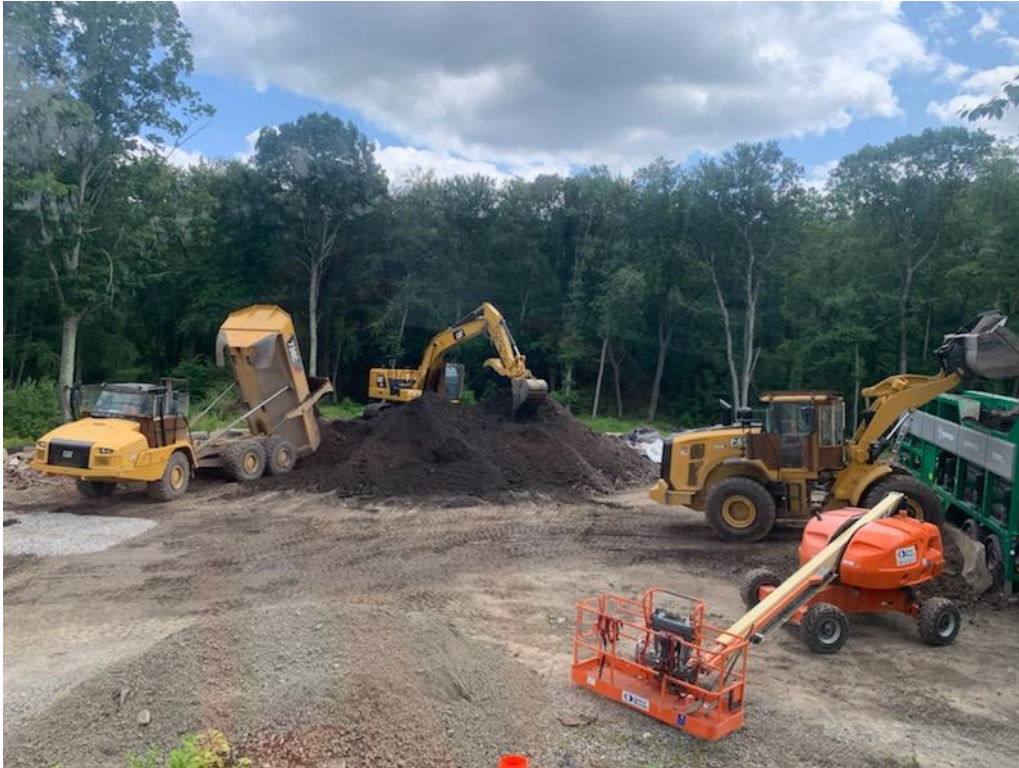
Loading material into screening plant

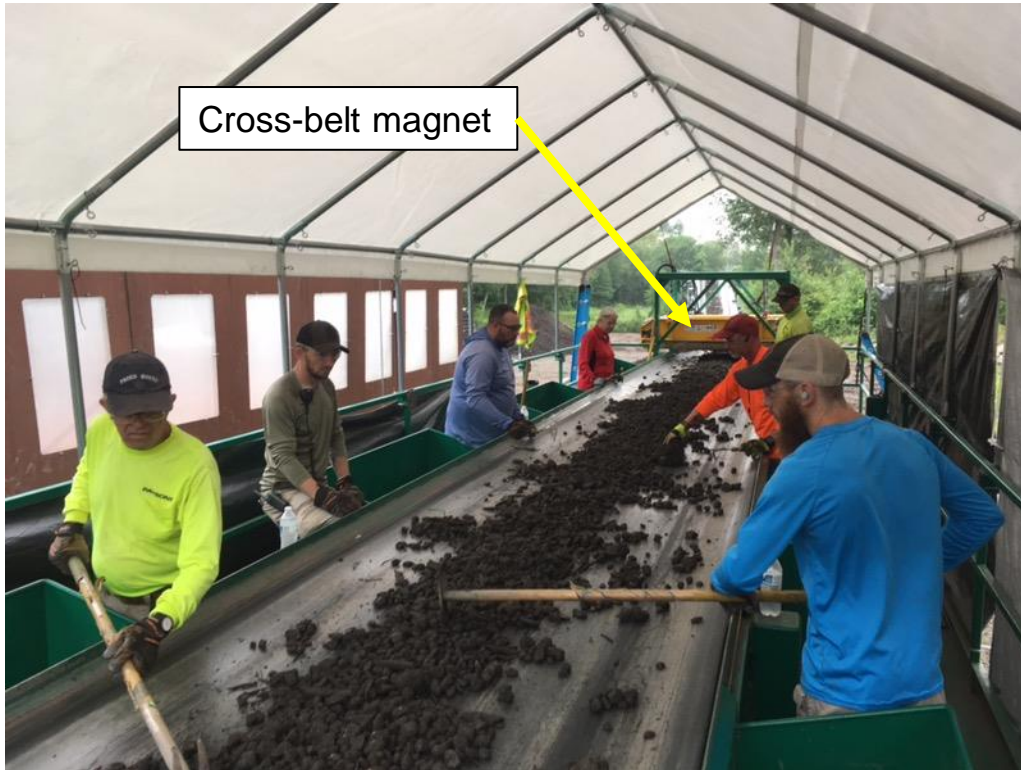
Technicians removing munitions

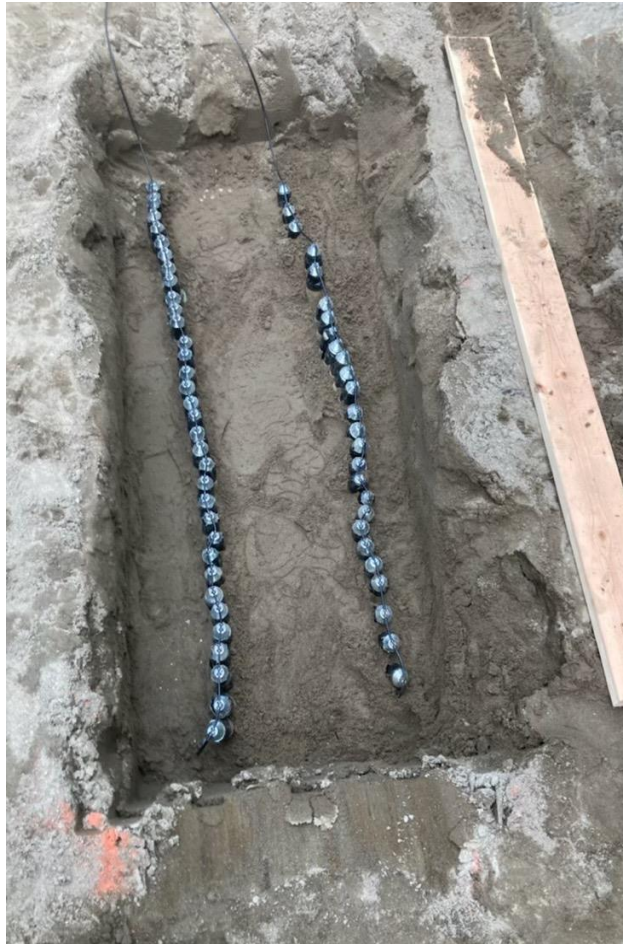
**Munitions
placed in
sand bed
and
connected
to
continuous
blasting
chord**

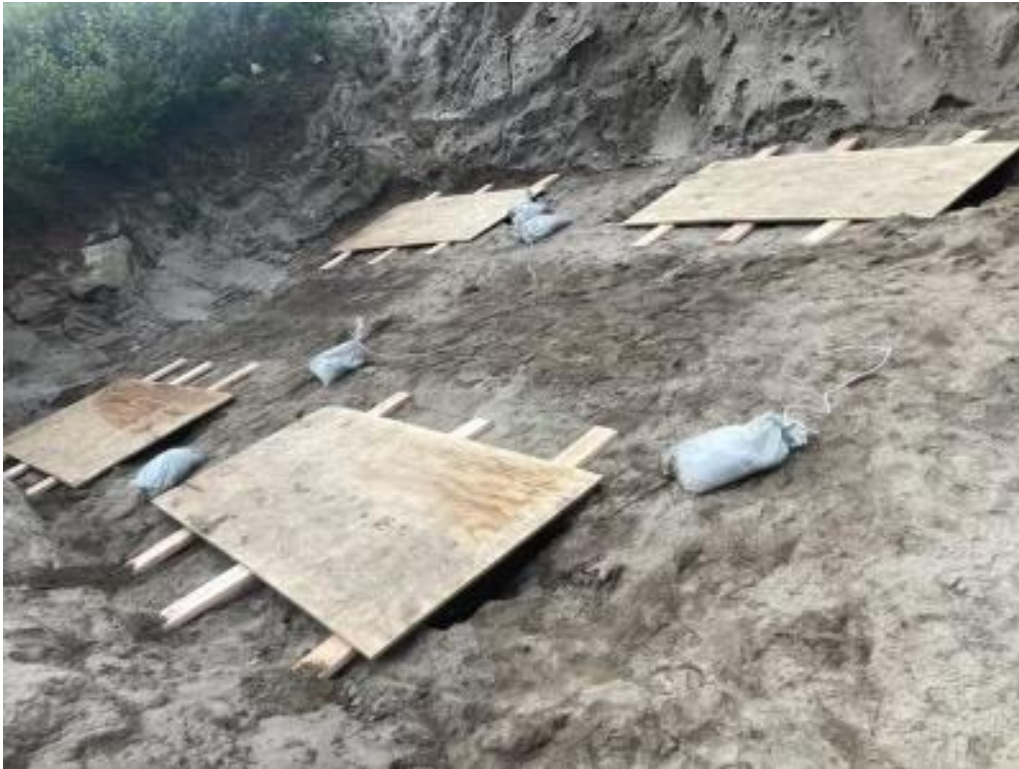
Blast beds covered by plywood prior to being covered with sand

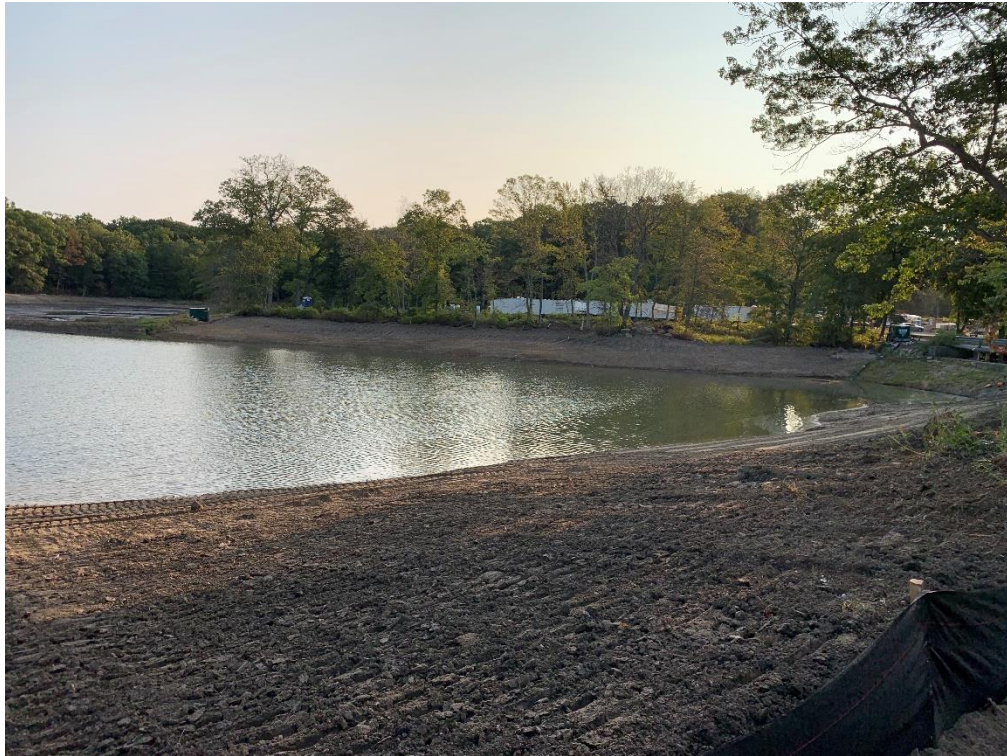
COMPLETED LAKE HABITAT BENCH

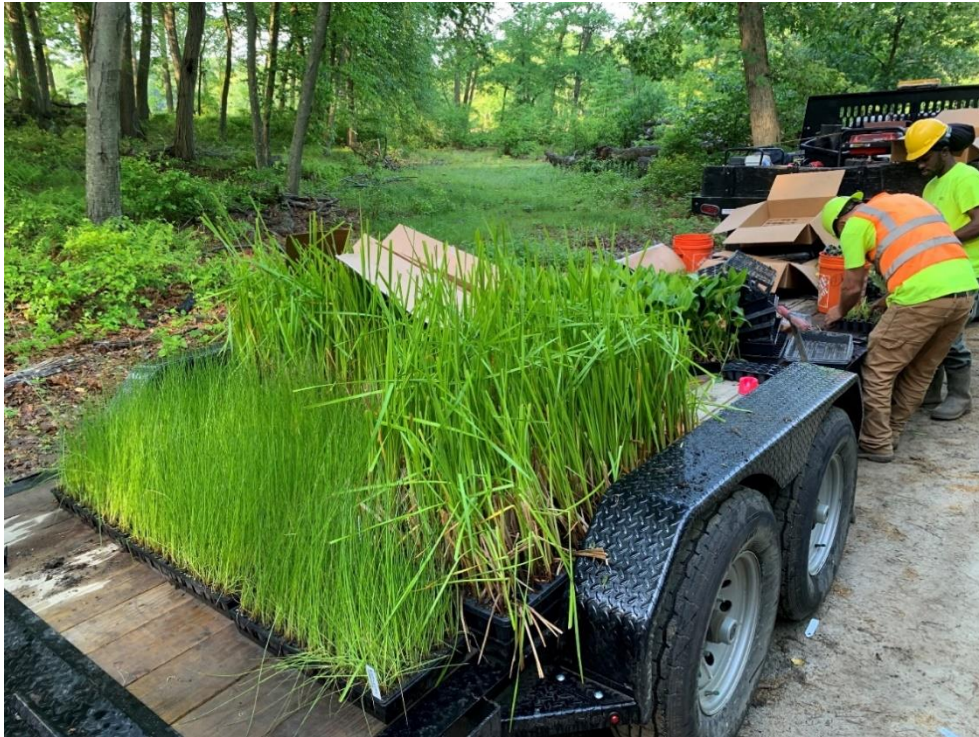
Littoral shelf plantings (plugs)

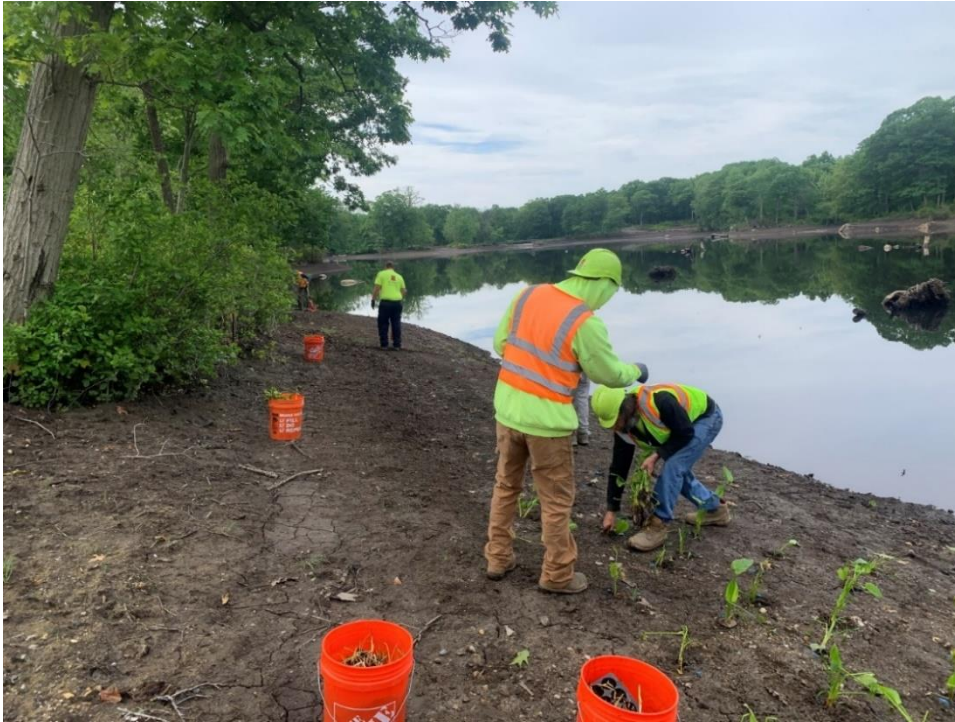
Installing plugs into gentle slope

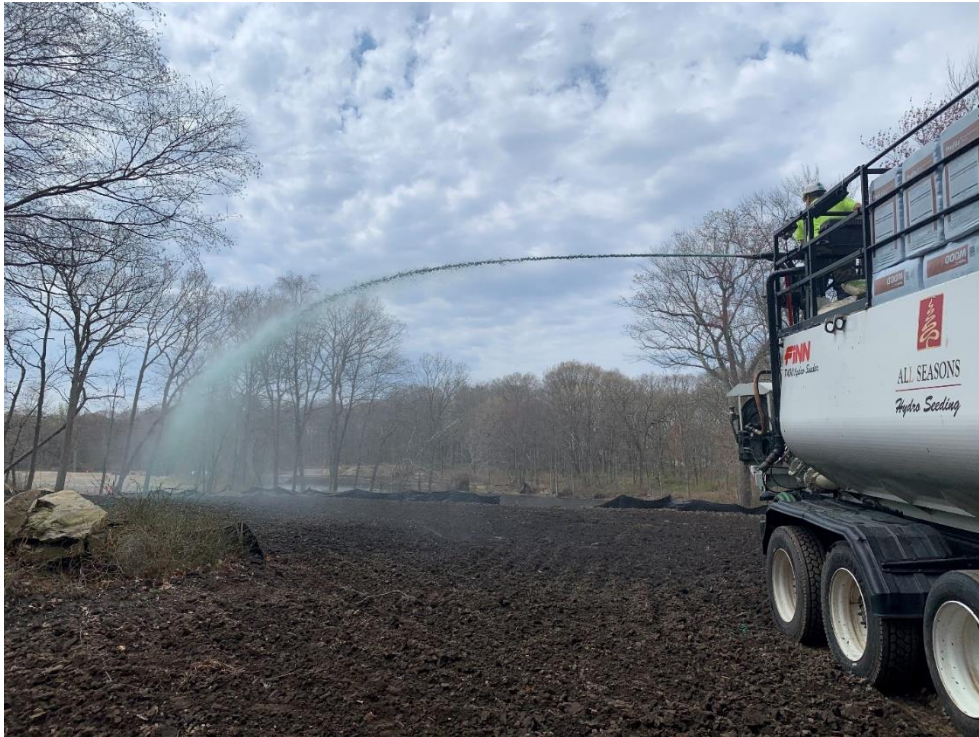
Hydroseeding operation for upland areas

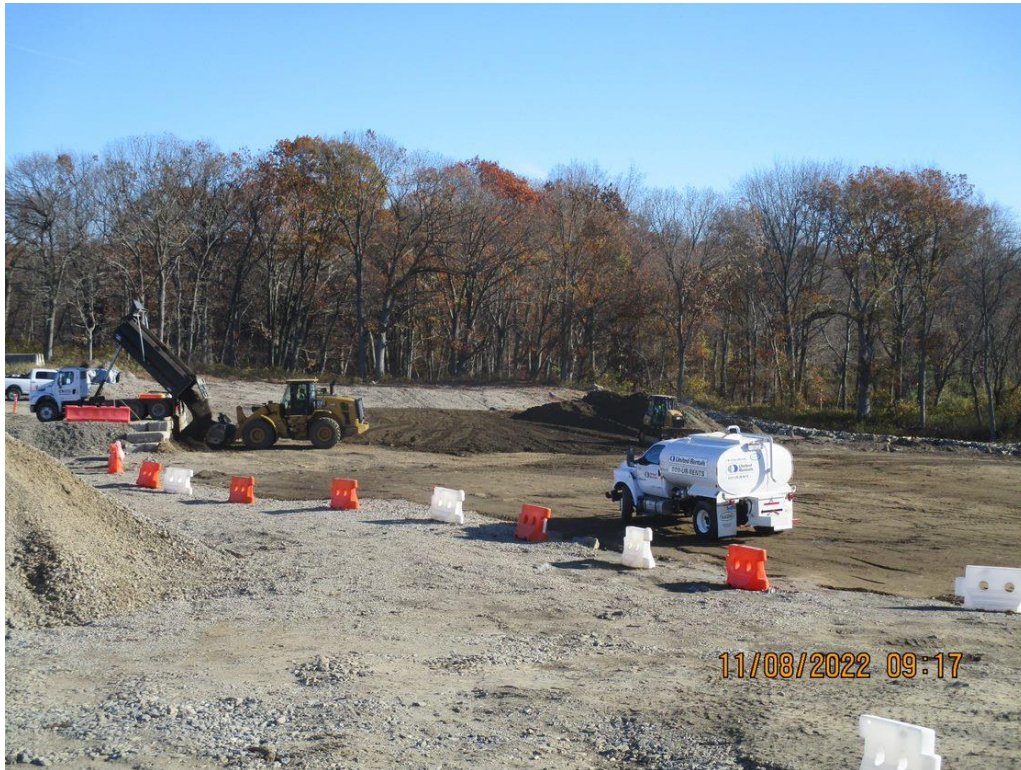
Soil placement in future cap area

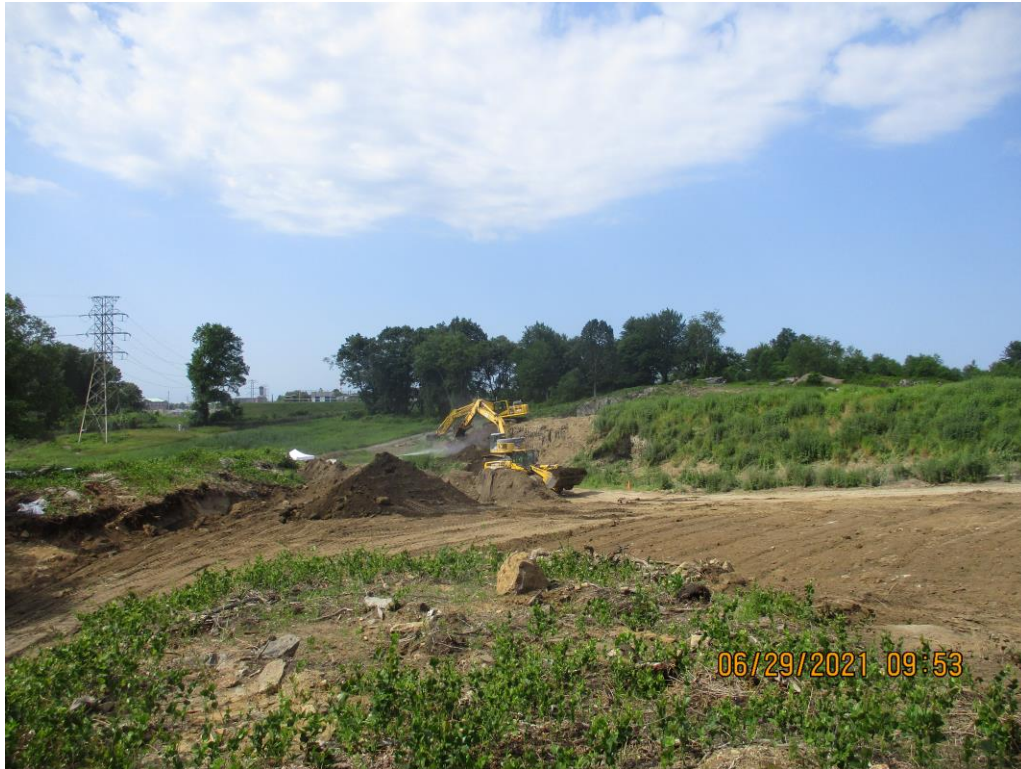
Spreading out soil in future cap area

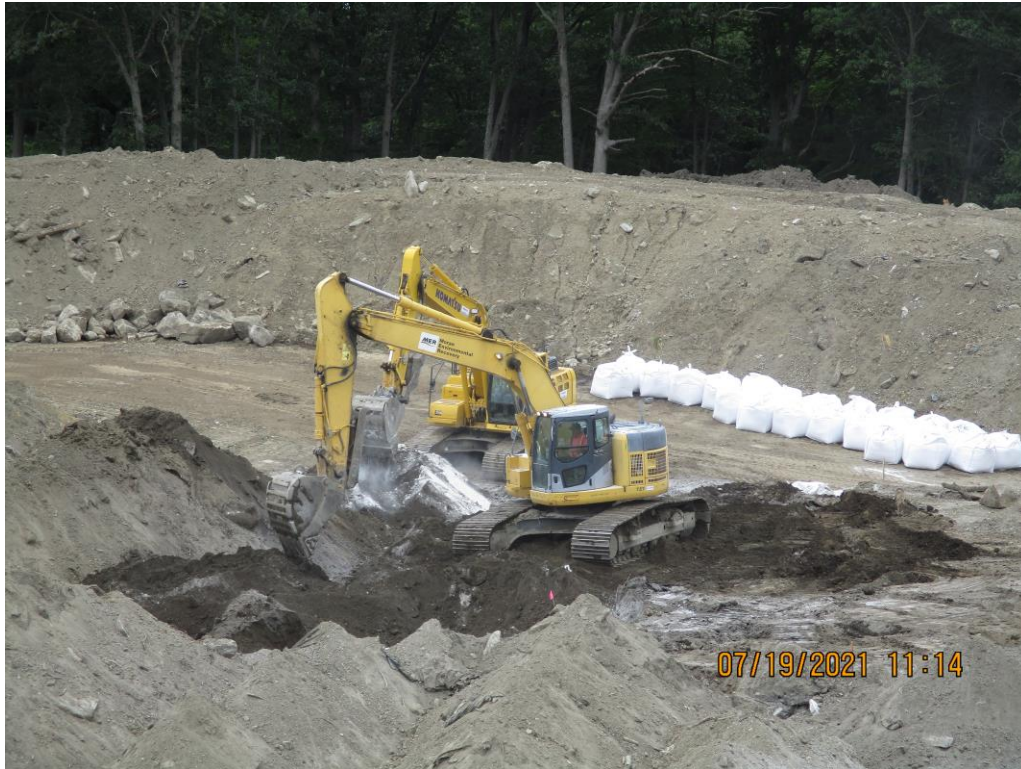
Stabilizing soil so that it meets EPA and CT DEEP requirements

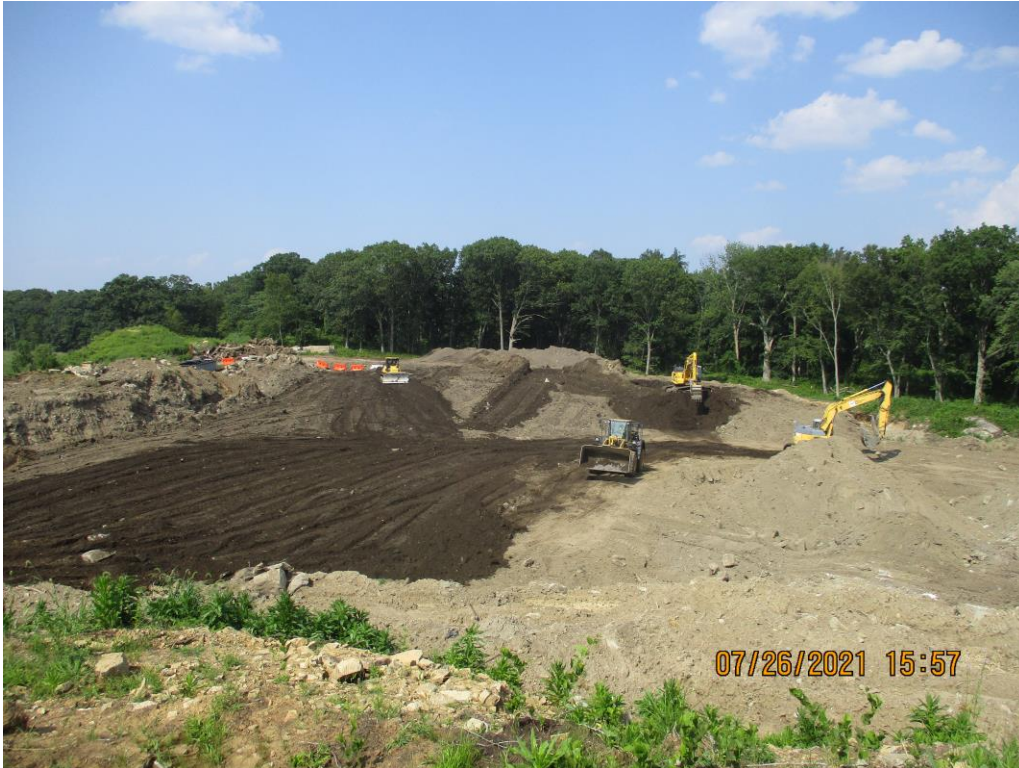
Placing soil in shallow lifts and compacting in place
